**SAFETY COMPLIANCE TESTING FOR FMVSS 201U**  
**Occupant Protection In Interior Impact**  
**Upper Interior Head Impact Protection**

**NEW UNITED MOTOR MANUFACTURING, INC.**  
**2003 Pontiac Vibe 4-Door SUV**  
**NHTSA No. C30105**

1. Report No. 201U-MGA-03-002	2. Government Accession No.	3. Recipient's Catalog No.	
4. Title and Subtitle Final Report of FMVSS 201U Compliance Testing of a 2003 Pontiac Vibe, NHTSA No. C30105		5. Report Date December 12, 2002

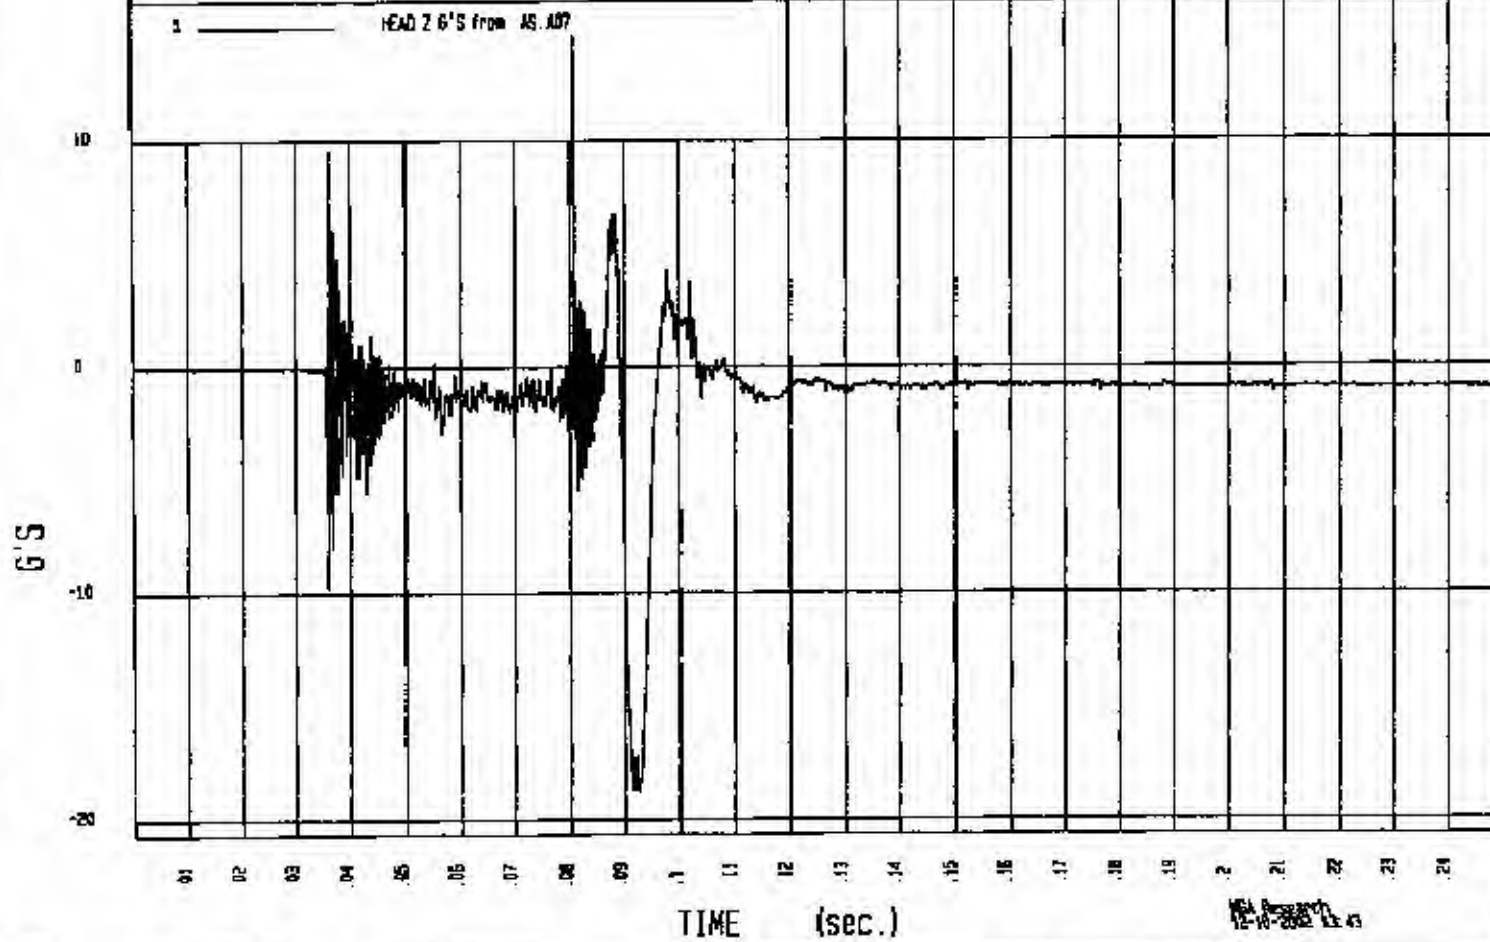
HEAD Z

TEST: 2003 PONTIAC VIBE FMVSS 201U, G03I5-001.2, 12/10/02

COMPONENT: TEST #2 (FM2386), R/S AP1, H/V=132/26

YMAX=14.8645 G'S at 80.5 msec

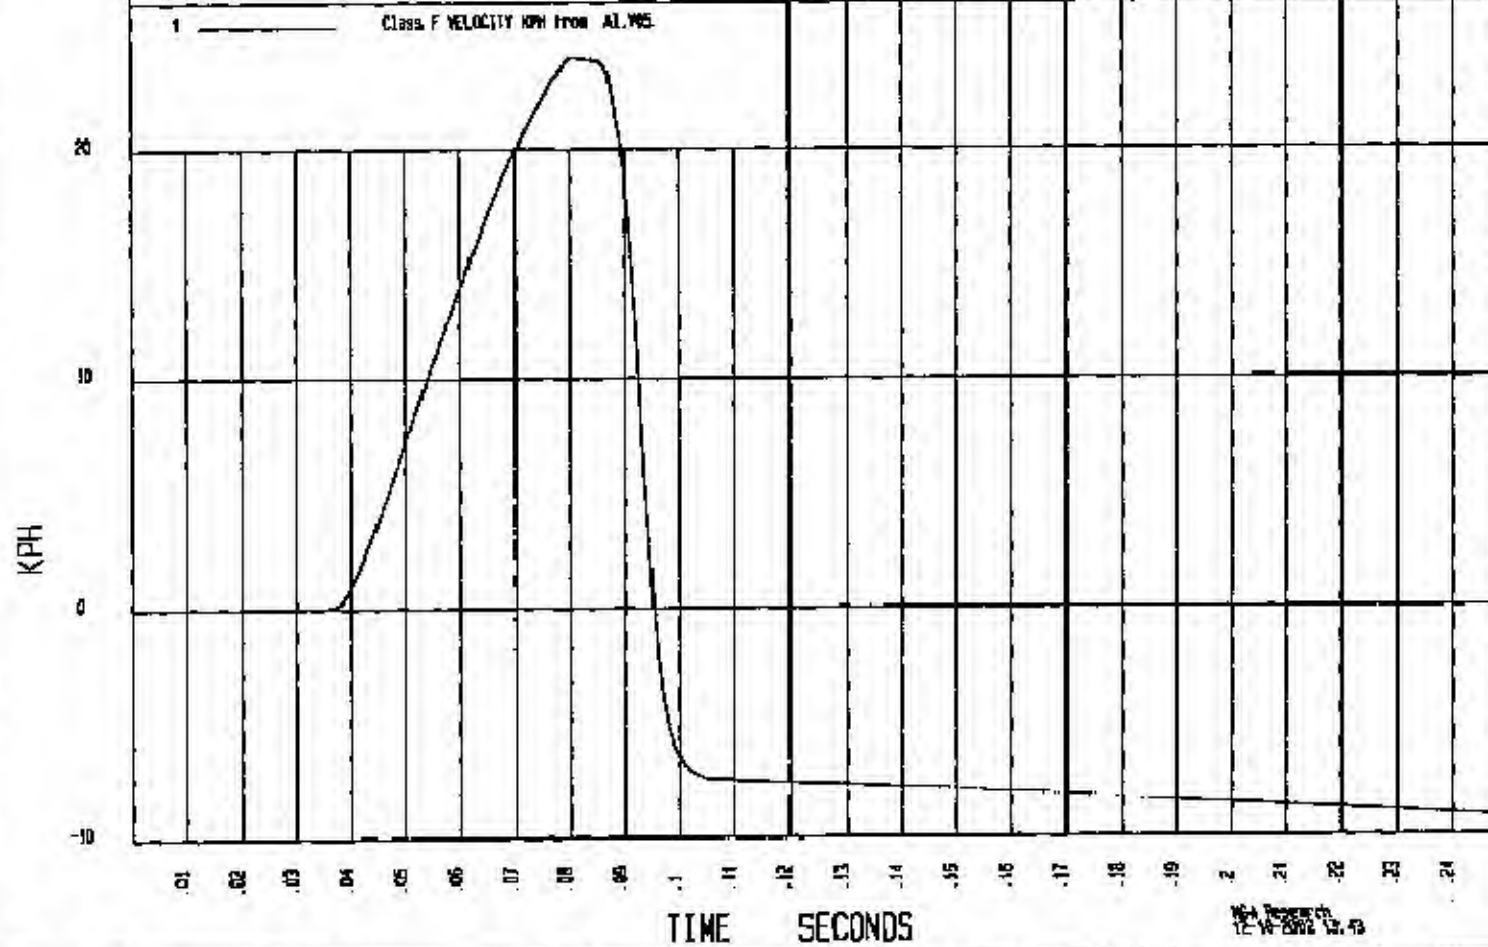
VELOCITY

TEST: 2003 PONTIAC VIBE FMVSS 2010, G03I5-D01.2, 12/10/02

COMPONENT: TEST #2 (FM2386), R/S AP1, H/V=132/26

YMAX=24.0125 KPH at 80.4 msec

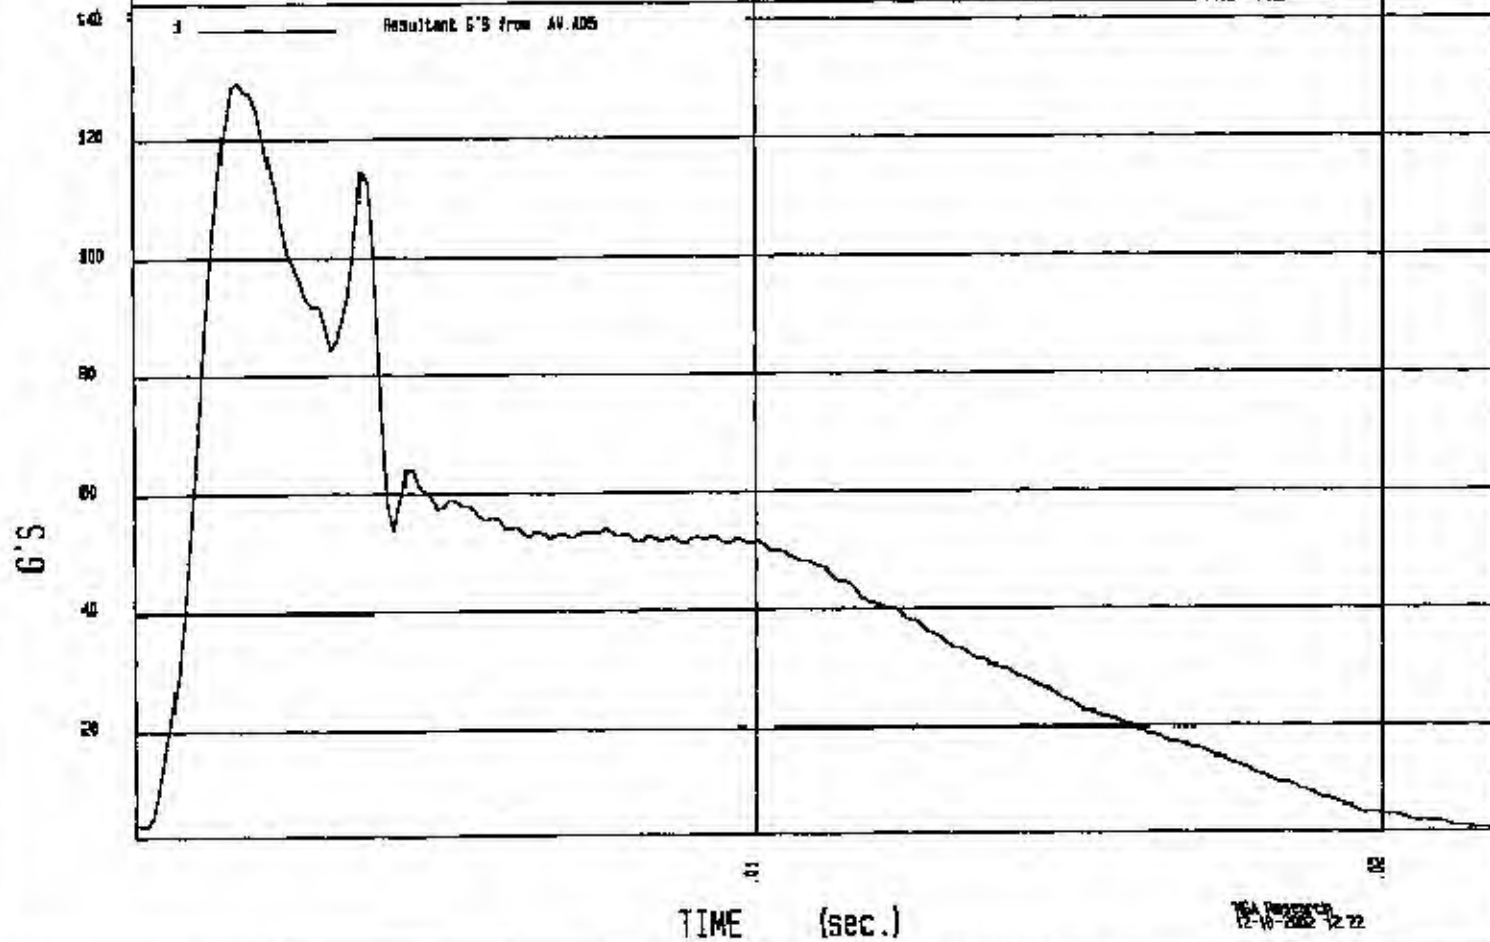
FMH RESULTANT

TEST: 2003 PONTIAC VIBE FMVSS 2010, C03I5-001.2, 12/10/02

COMPONENT: TEST #1 (FM2385), R/S AP3, H/V=159/44

YMAX= 129.7838 G'S at 1.69 msec

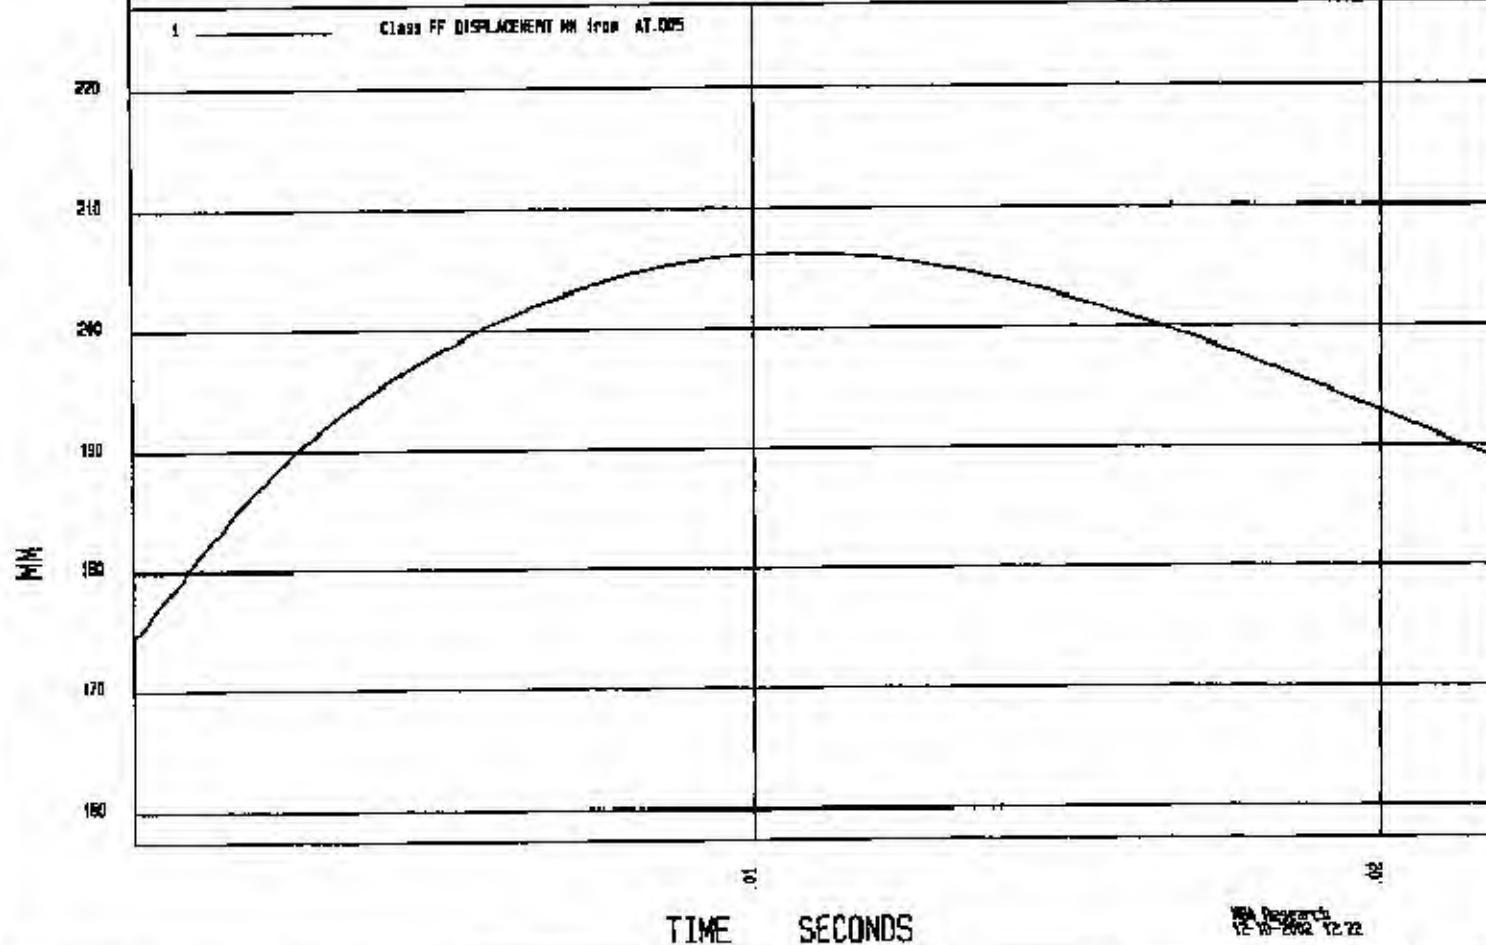
### DISPLACEMENT

TEST: 2003 PONTIAC VIBE FMVSS 2010, G03I5-001.2, 12/10/02

COMPONENT: TEST #1 (FM2385), R/S AP3, H/V=159/44

YMAX= 206.2011 MM at 10.8 msec

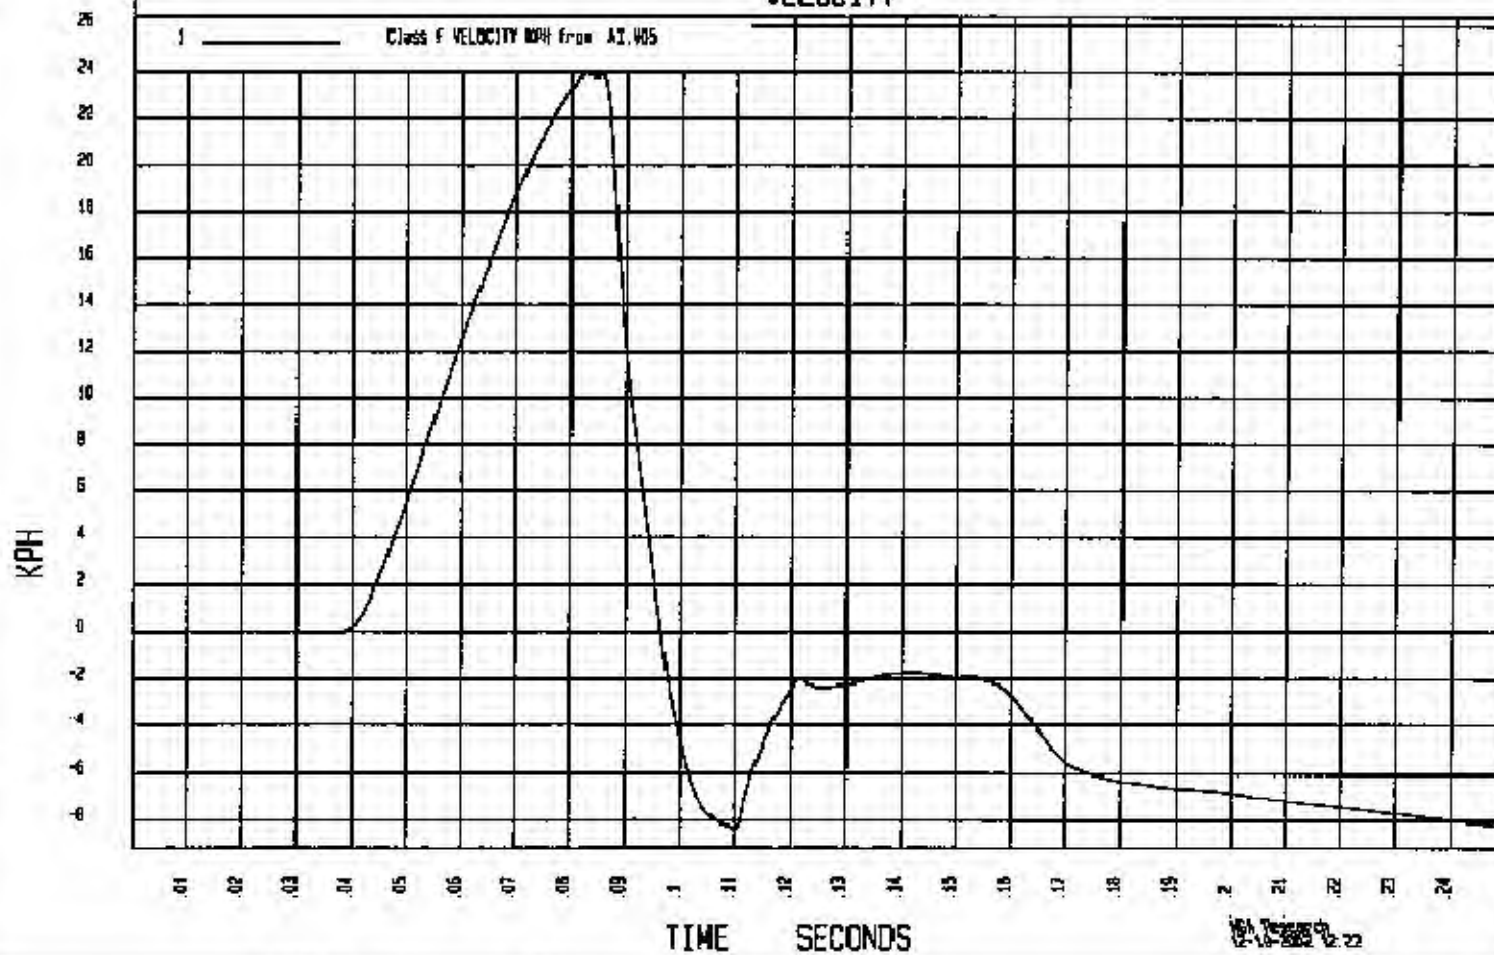
### VELOCITY

TEST: 2003 PONTIAC VIBE FMVSS 2010, G03I5-001.2, 12/10/02

COMPONENT: TEST #1 (FM2385), R/S AP3, H/V=159/44

YMAX=23.90853 KPH at 82.4 msec

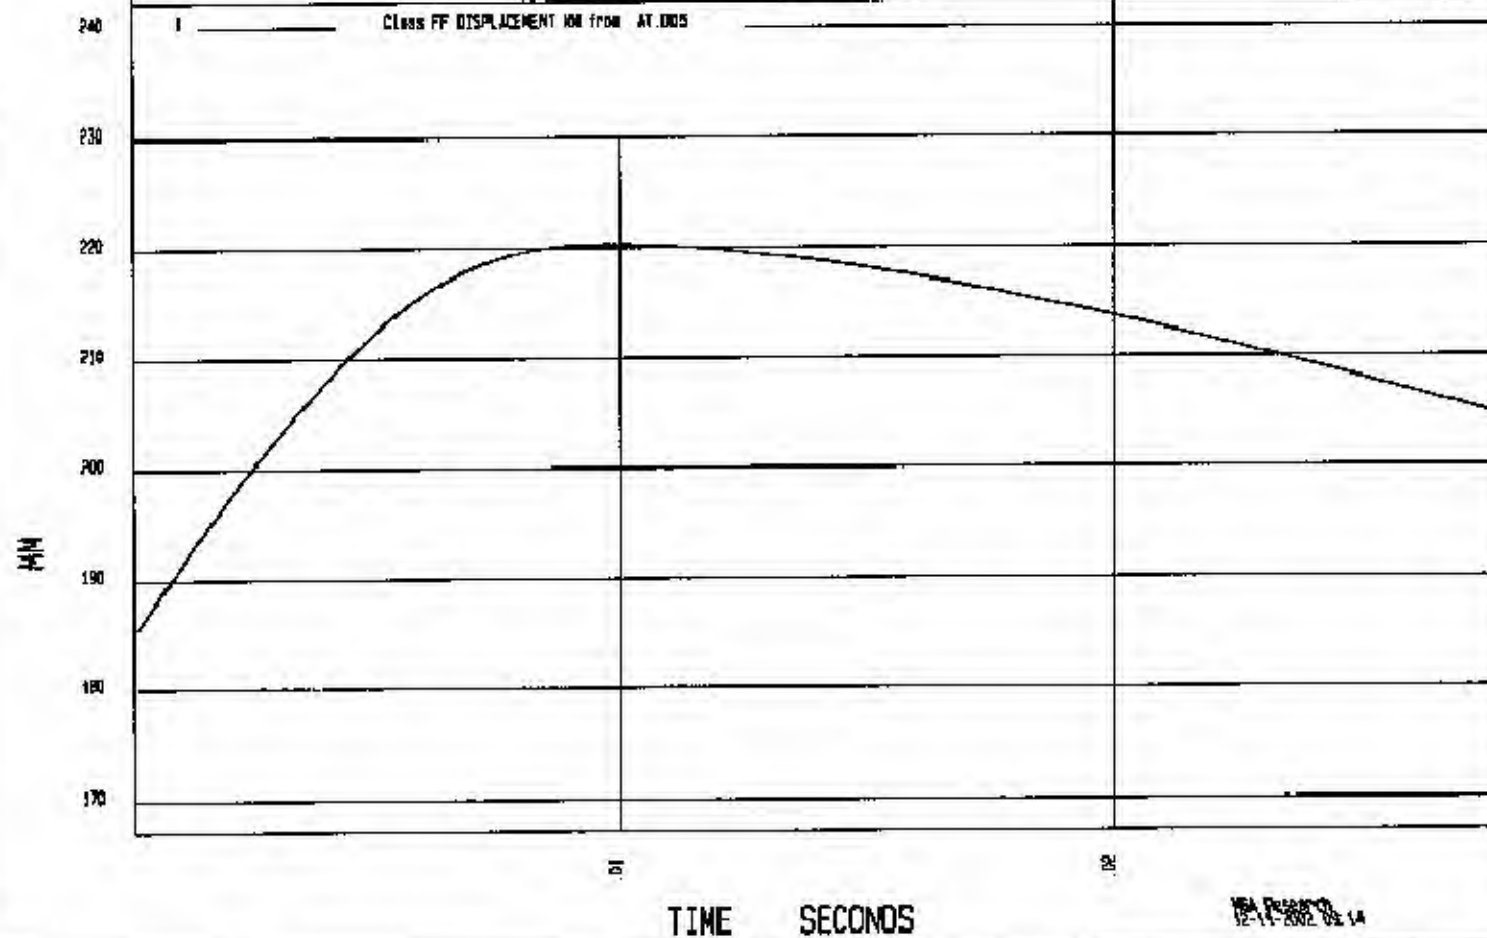
### DISPLACEMENT

TEST: 2003 PONTIAC VIBE FMYSS 201U, G03I5-001.2, 12/11/02

COMPONENT: TEST #6 (FM2390), R/S DP1, H/V=90/6

YMAX= 220.3331 MM at 9.76 msec

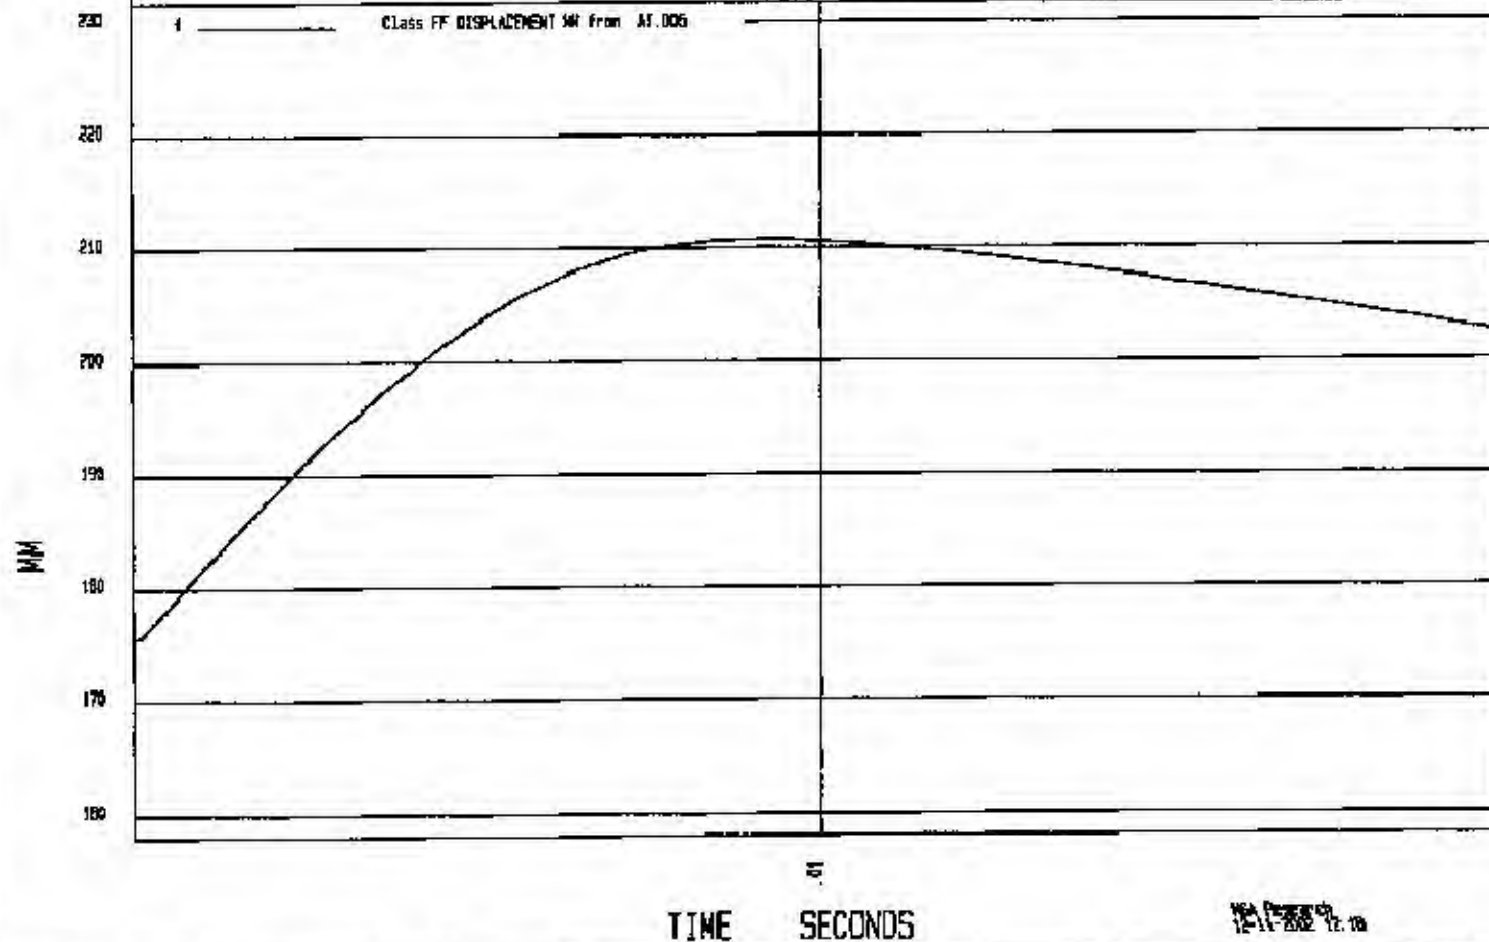
### DISPLACEMENT

TEST: 2003 PONTIAC VIBE FMVSS 201U, G03I5-001.2, 12/11/02

COMPONENT: TEST #9 (FM2393), L/S SR2A, H/V=270/33

YMAX= 210.5942 MM at 9.15 msec

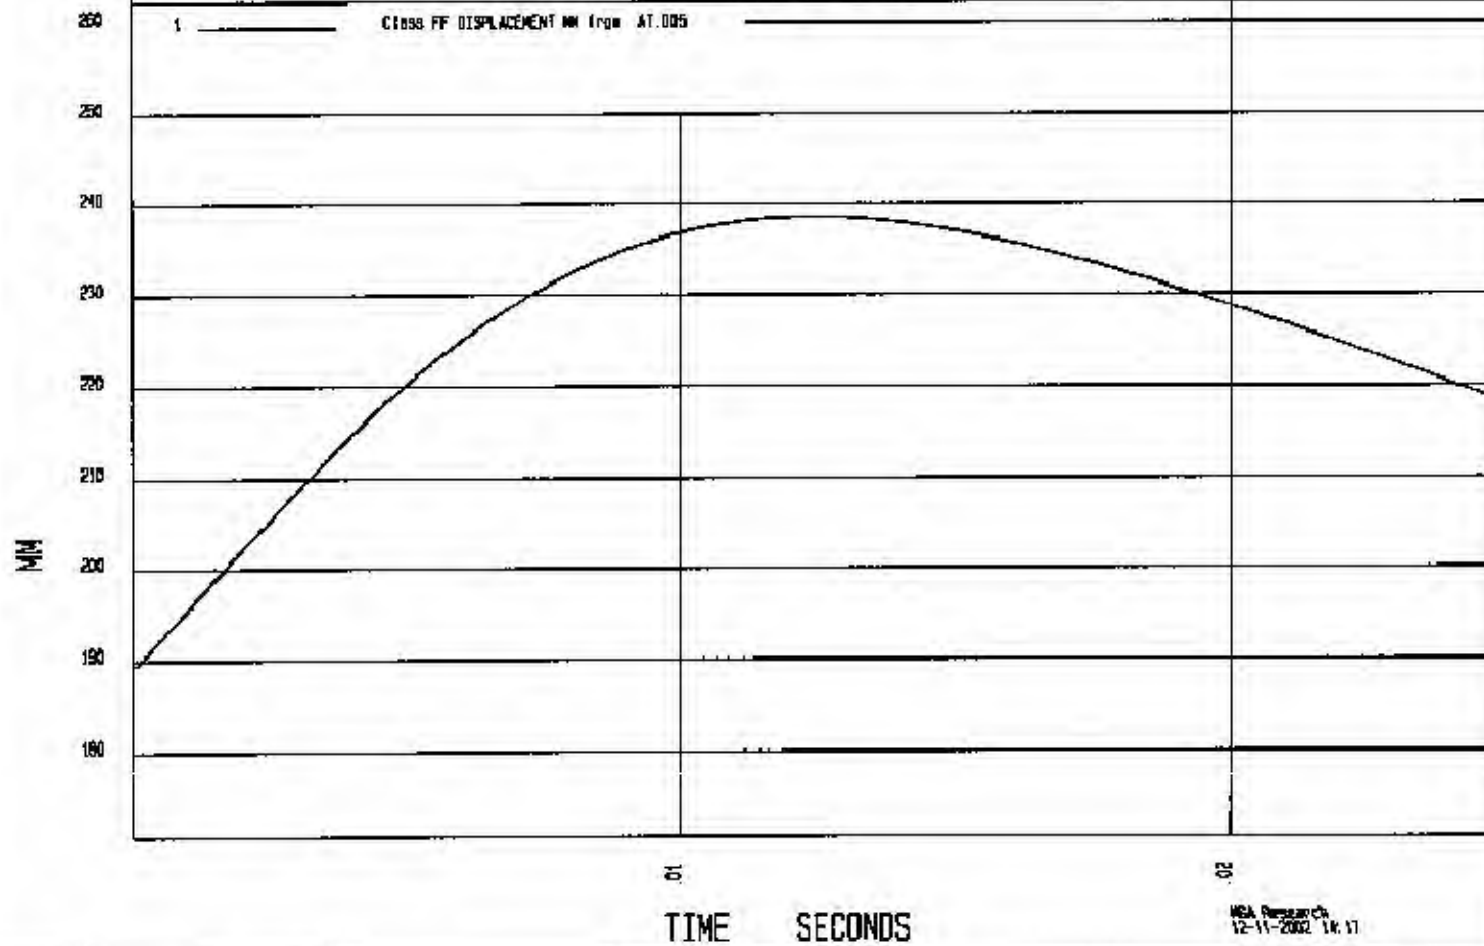
### DISPLACEMENT

TEST: 2003 PONTIAC VIBE FMVSS 201U, G0315-001.2, 12/11/02

COMPONENT: TEST #10 (FM2394), L/S UR2, H/Y=270/34

MAX= 238.44 MM at 12.4 msec

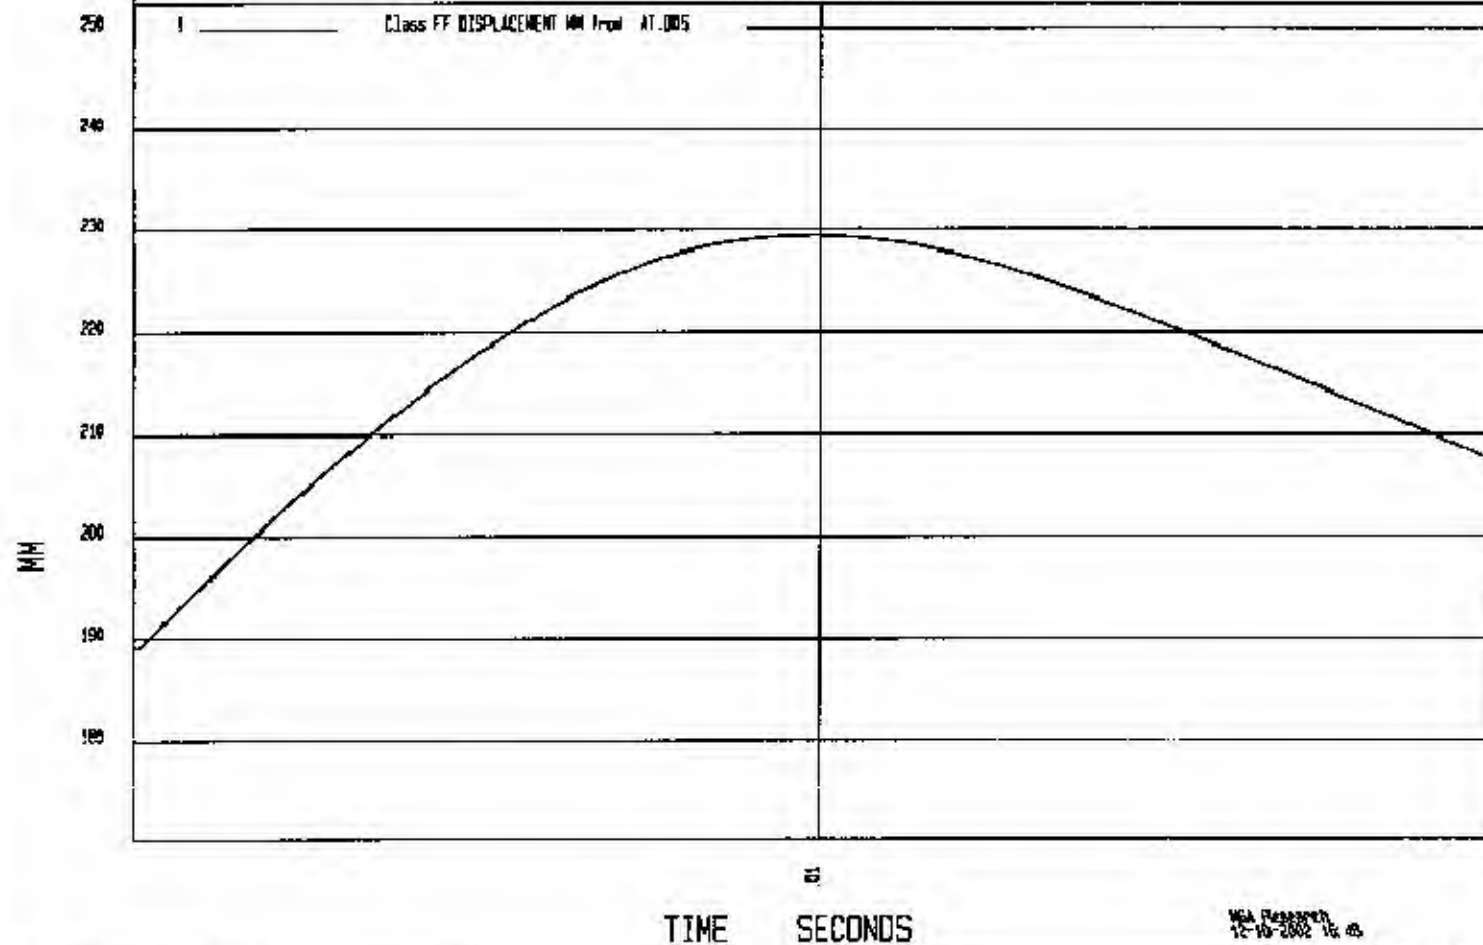
### DISPLACEMENT

TEST: 2003 PONTIAC VIBE FMVSS 201U, 60315-001.2, 12/10/02

COMPONENT: TEST #5 (FM2389), R/S UR4, H/V=90/50

YMAX= 229.3961 MM at 9.05 sec

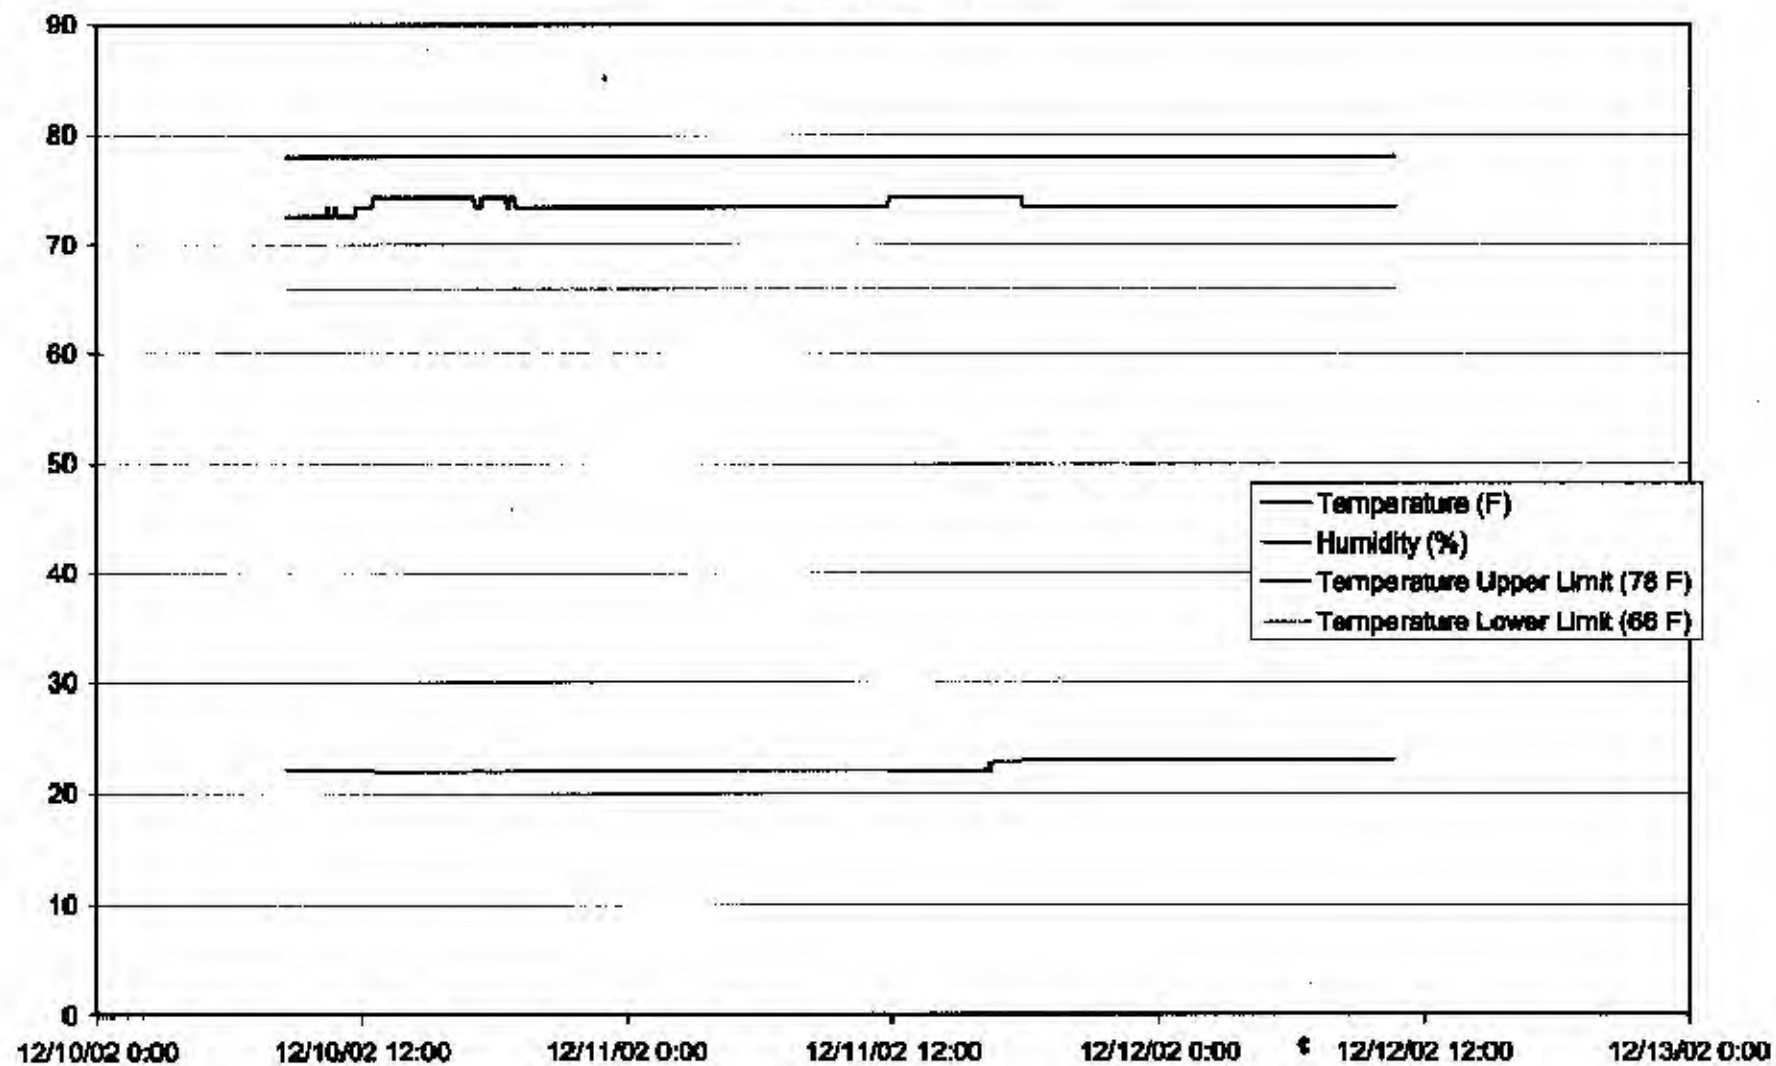
### C30105 Temperature Trace 12/10-12/02

The following section lists the test equipment for the compliance test series. Items marked with an asterisk are calibrated by an external lab. An additional summary table is given for the pre and post-test calibration data for the Free Motion Headforms. The temperature trace to confirm testing was conducted between 66°F and 78°F (19°C - 26°C) is included in Appendix A.
